# Smoke and Dye Testing Summary

## High Level Sewershed

Test ID	Test Type	Date Inspected	Company / Super.	Blower MH	Ground Condition	Notification Made?	Total Length
S1028-195	Smoke	7/27/2009	ADS/TM	S15A_021MH	Dry	Yes	977.05

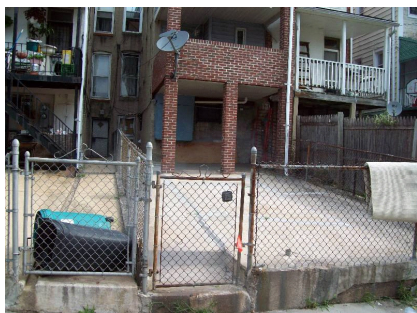
**Picture** \S1028-195-OB01-P01.jpg

**Source** Service Lateral

**Location** Paved concrete

**Comments** Smoke from service lateral under paved concrete in back yard. 2547 Calverton Heights Ave.

**Comments** Back of house, 2547 Calverton Heights Ave.

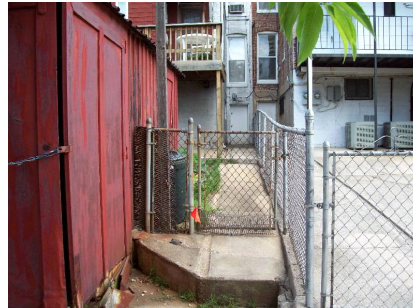
**Picture** \S1028-195-OB02-P01.jpg

**Source** Cleanout

**Location** Paved concrete

**Comments** Smoke from cleanout in paved concrete in back yard. 2545 Calverton Heights Ave.

**Comments** Back of house, 2545 Calverton Heights Ave.
